CHURCH OF THE HOLY SEPULCHRE JERUSALEM

STRUCTURAL SURVEY
FINAL REPORT

BY
WILLIAM HARVEY

1935

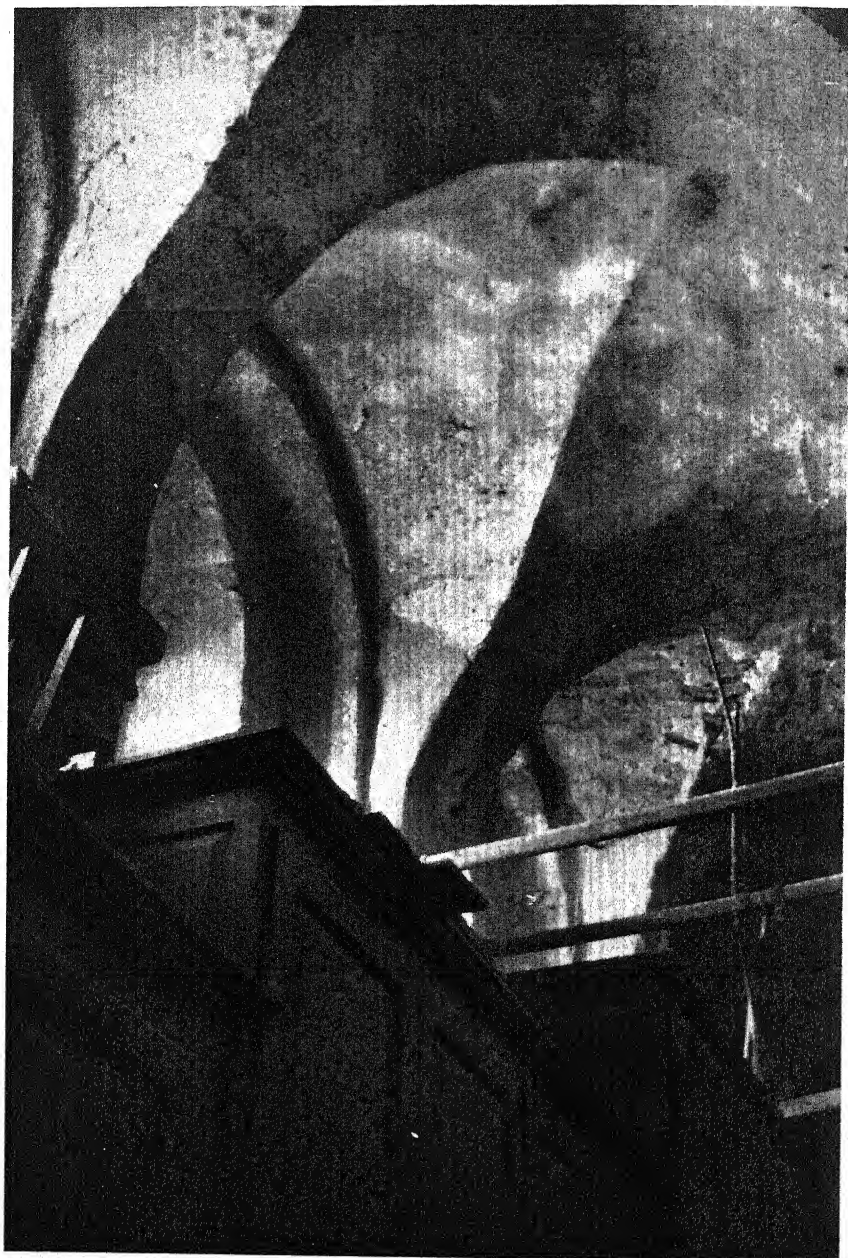
During plastering which took place eighteen months ago, it was found that the vault of the upper gallery was not in contact with the outer wall in many places (see Fig. 10); the very large cracks then visible are now hidden by the new plaster, but within the last few months the plasterwork has again shown cracks in the same positions as the hidden defects, thus indicating that movement is now continuing. The carved stone capitals of the attached half-columns supporting this vault are badly cracked owing to the pressure and torsion to which they are subjected.

FIG. 10. VAULT OF NORTH TRANSEPT UPPER GALLERY—
BEFORE RE-PLASTERING

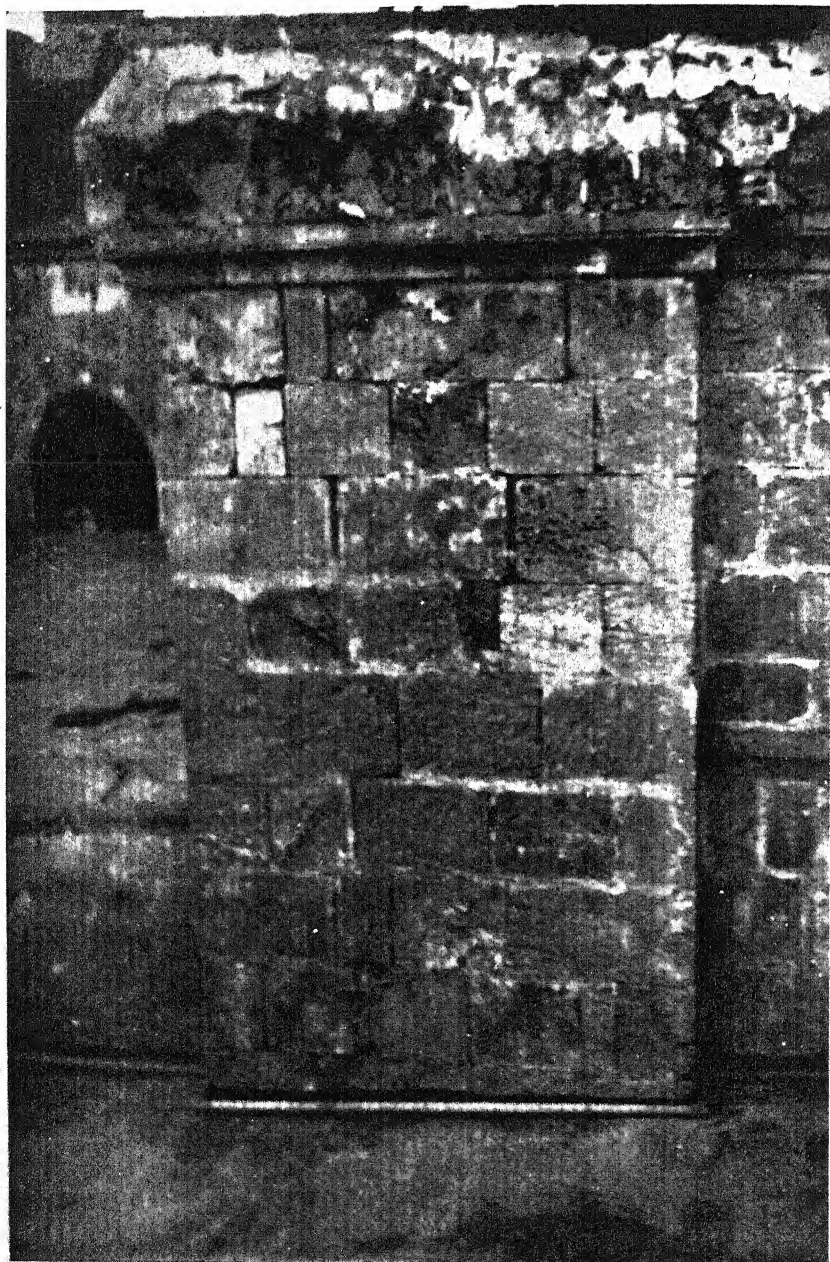
The high vault itself (see Fig. 11) has also been plastered, but some two years ago a large stone fell from one of the main ribs, and the upper walls, where accessible from outside, are in an extremely poor condition (see Figs 12, 13, 14), many joints being completely denuded of mortar, and much of the masonry cracked and suffering from erosion, and to some extent from the effects of the fire of 1808.

FIG. 12. N.E. CORNER OF NORTH TRANSEPT

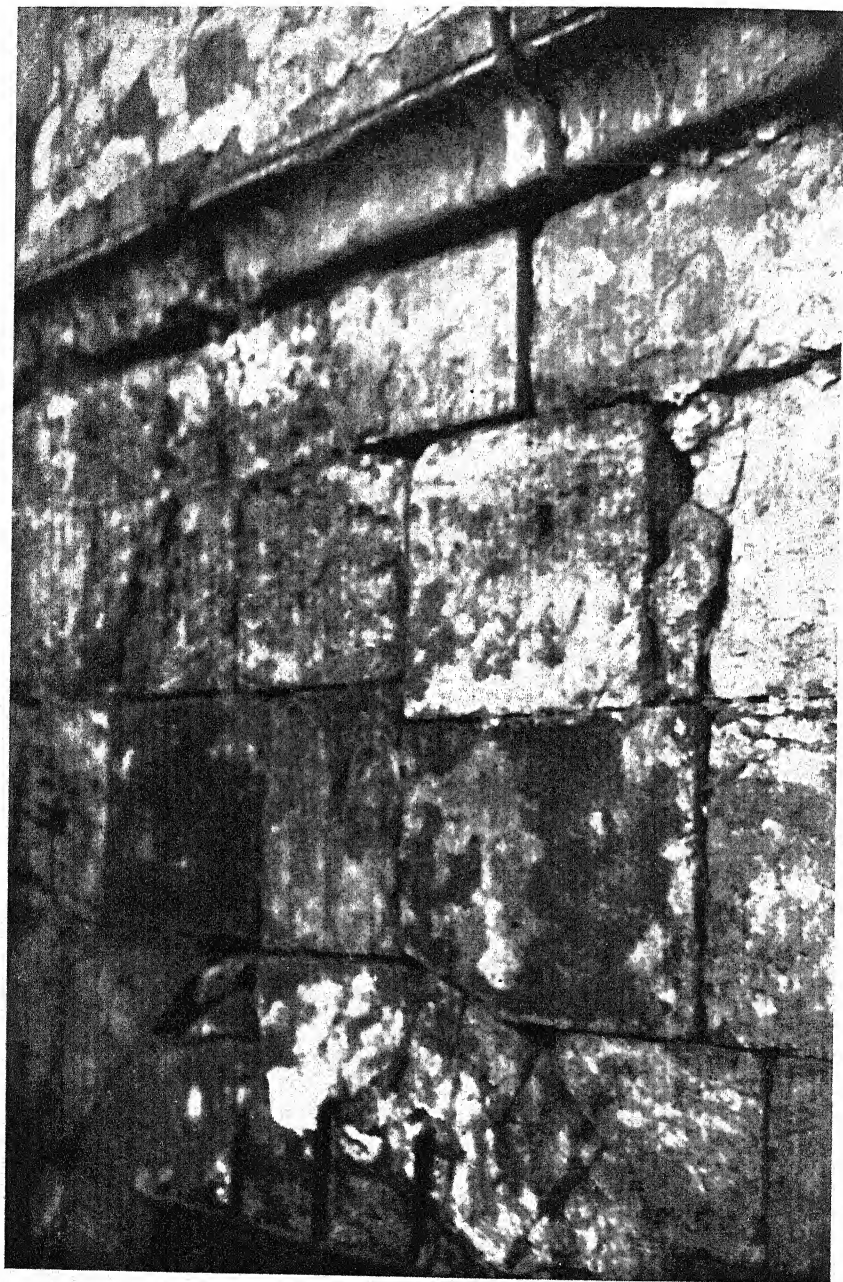
FIG. 14. NORTH TRANSEPT HIGH VAULT. E. WALL

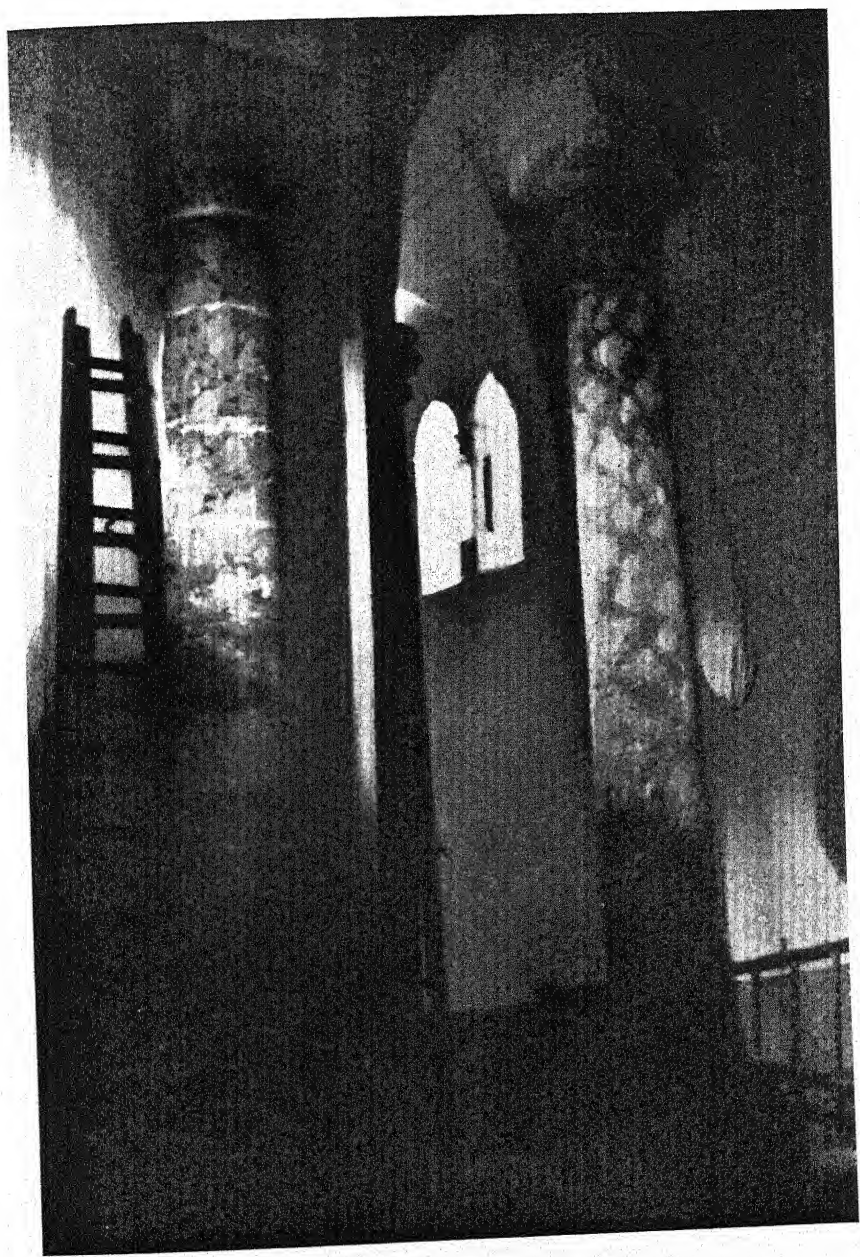
The marble columns of the Byzantine arcade (see Fig. 15) are seriously cracked as a result of the thrusts, and of the great weight resting upon them. The cracks appear to be recent, and loose splinters of the marble can be detached.

FIG. 15. E. COLUMN OF BYZANTINE ARCADE

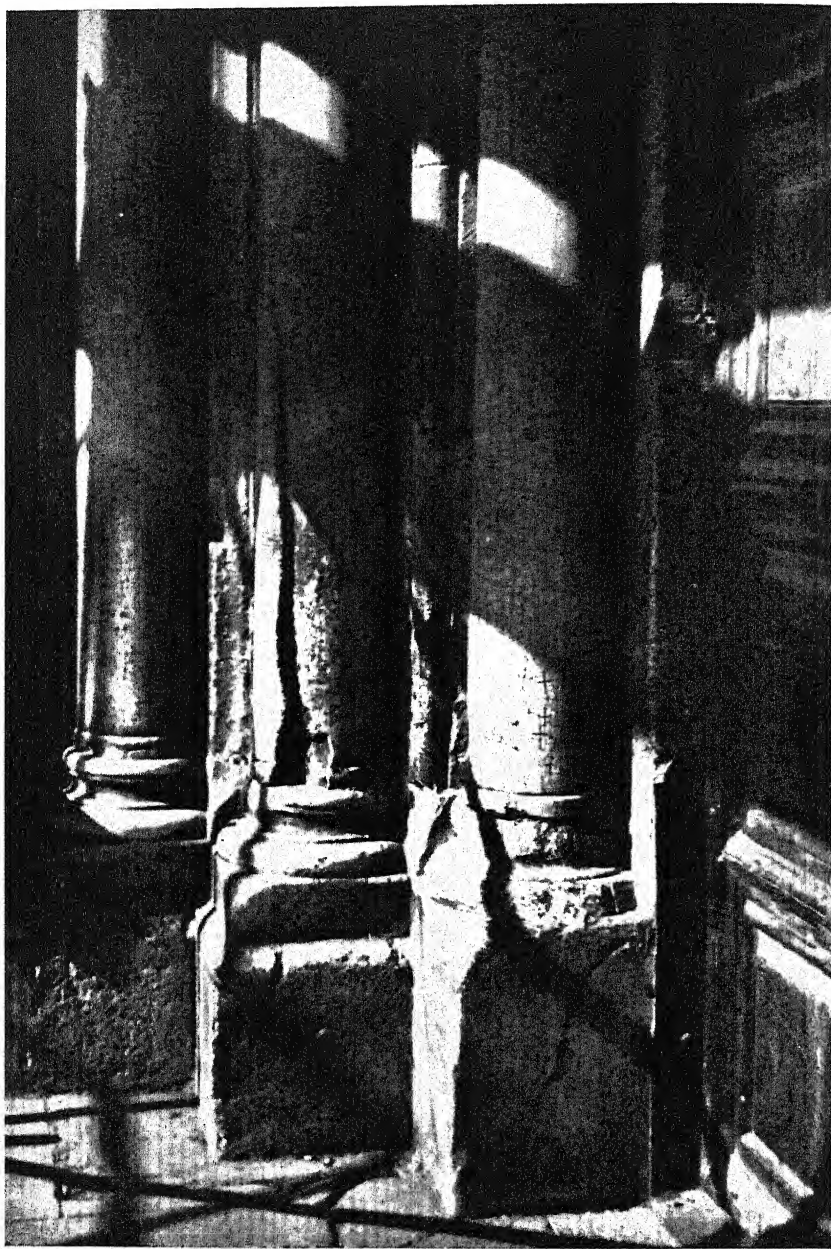
The lower colonnettes and their bases are almost all cracked, the oblique direction of the cracks showing the asymmetrical loading of the arches above (see Fig. 24). The condition of most of the carved work is extremely good (see Figs. 25, 26, 27, 28, 29) with the exception of the inner orders of the upper arches, which suffered most from the fire (see Figs. 30, 31, 32).

FIG. 24. BASES TO W. OF MAIN DOOR

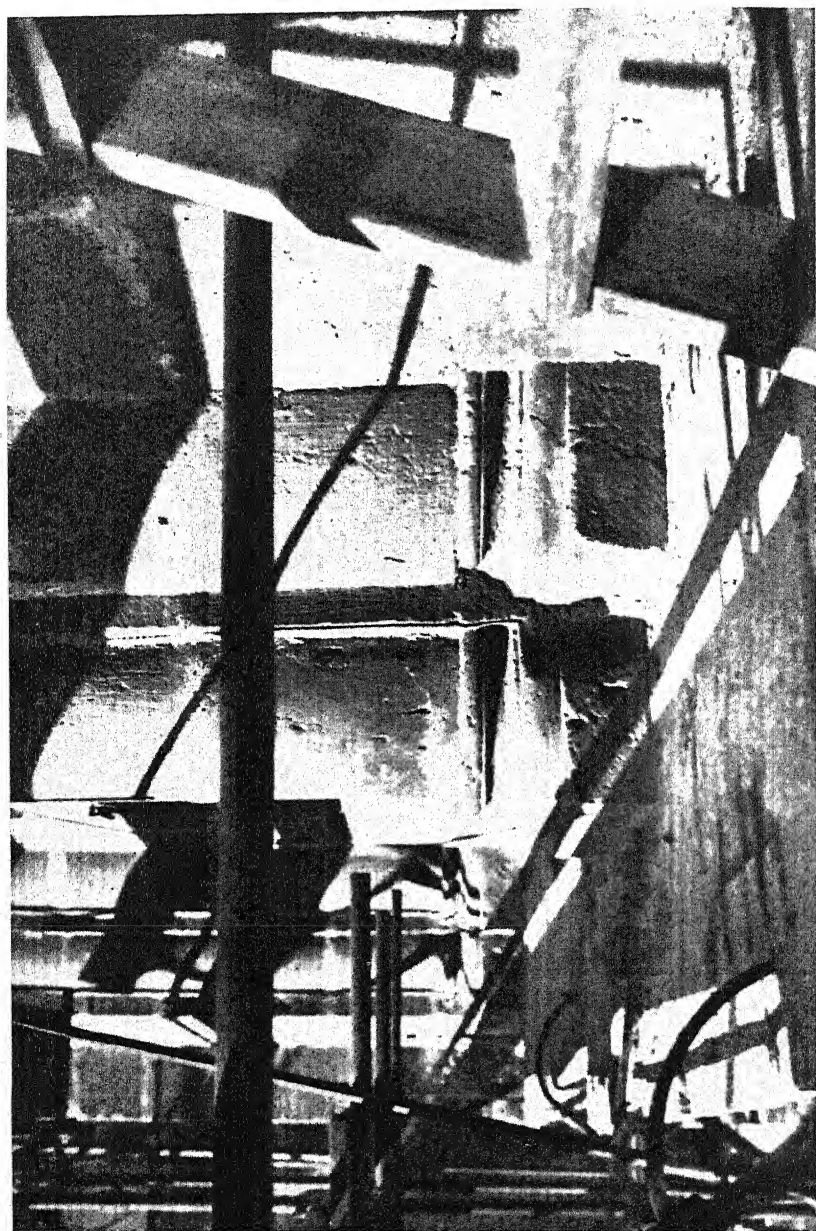
Serious cracks occur both from the outside of the wall (see Fig. 36) and in the attached pier within (see Fig. 37); while others between the vault and the wall have been covered by plaster (see Fig. 38) (see also Additional Notes, pp. 13 and 15).

FIG. 36. CRACKED BASES OF PIERS OF UPPER ARCADE

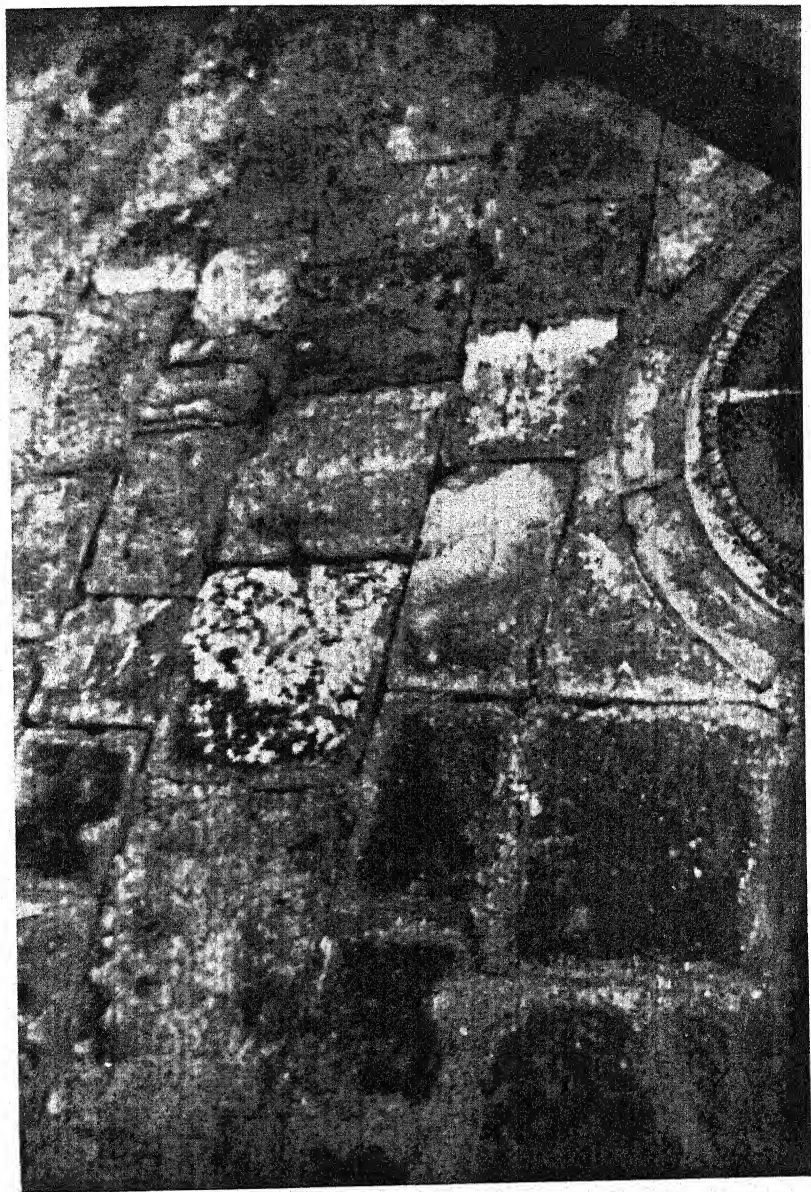
FIG. 36a. SOUTH TRANSEPT HIGH VAULT E. WALL TO SHOW FRACTURES
IN MASONRY AND JOINTS

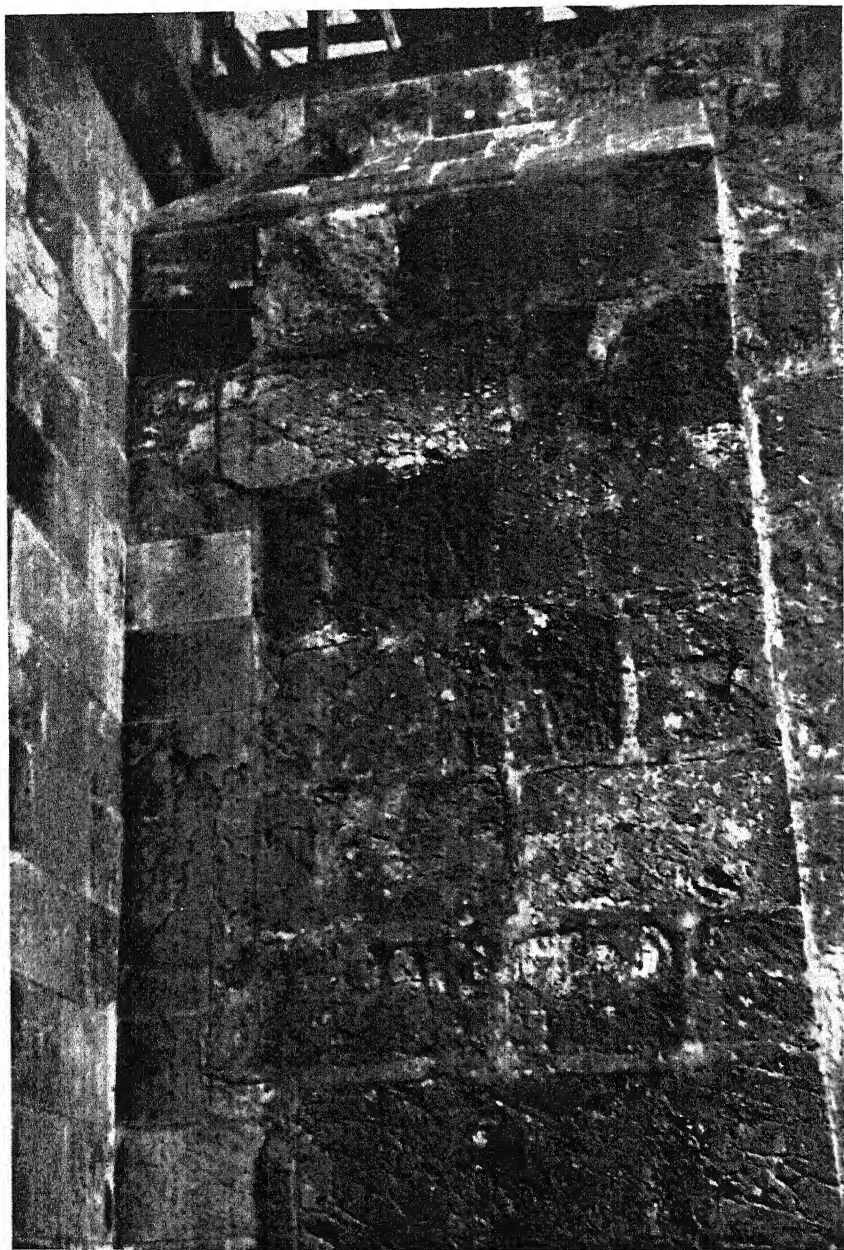
FIG. 36b. SOUTH TRANSEPT HIGH VAULT W. WALL
TO SHOW CRACK

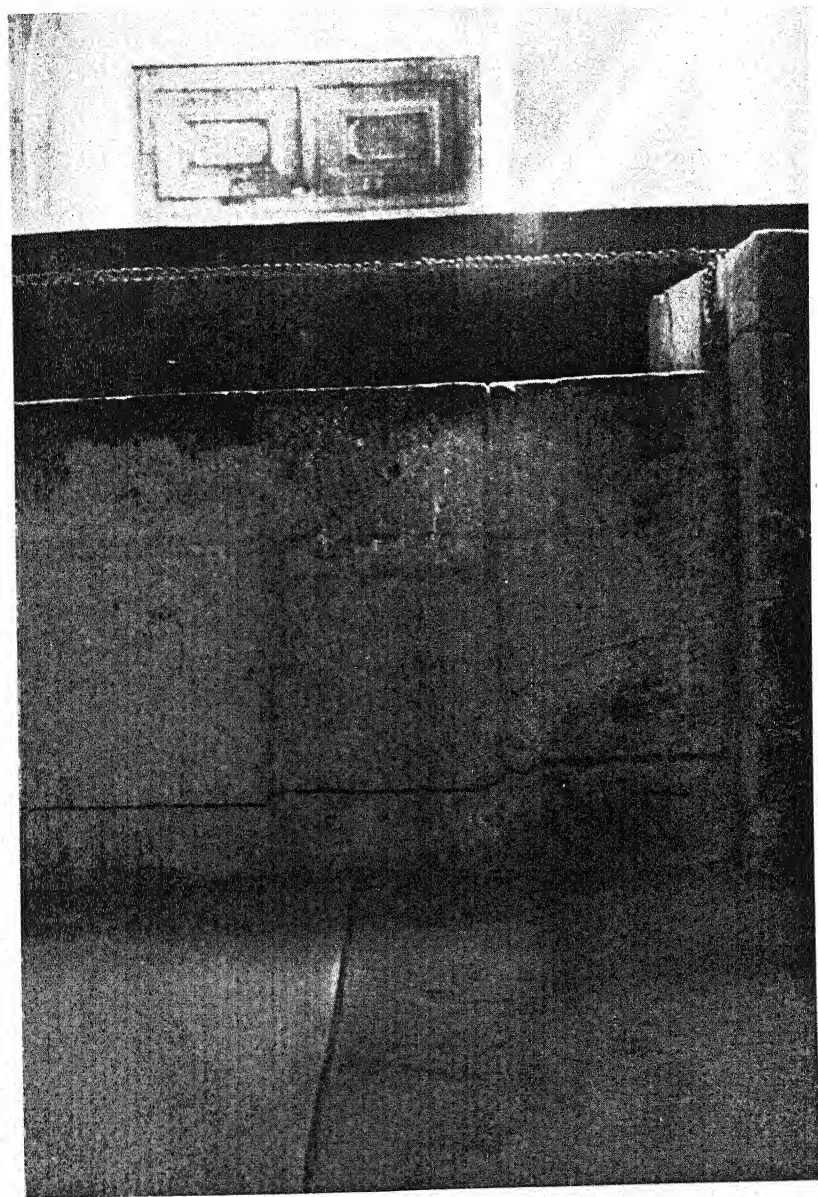
FIG. 37. FRACTURE IN ATTACHED PIER BETWEEN MAIN DOORS

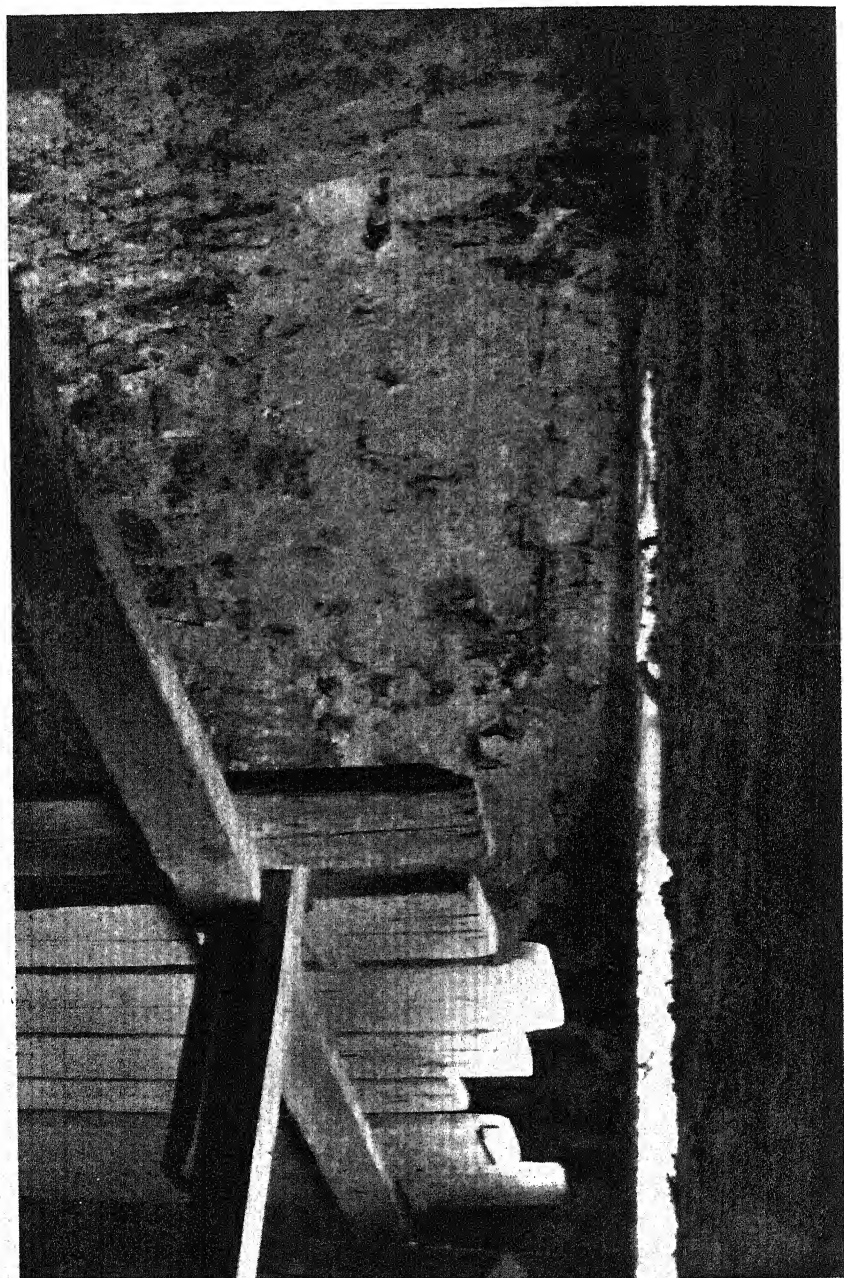
FIG. 38. CRACKED VAULT OF ARMENIAN GALLERY
BEFORE RE-PLASTERING

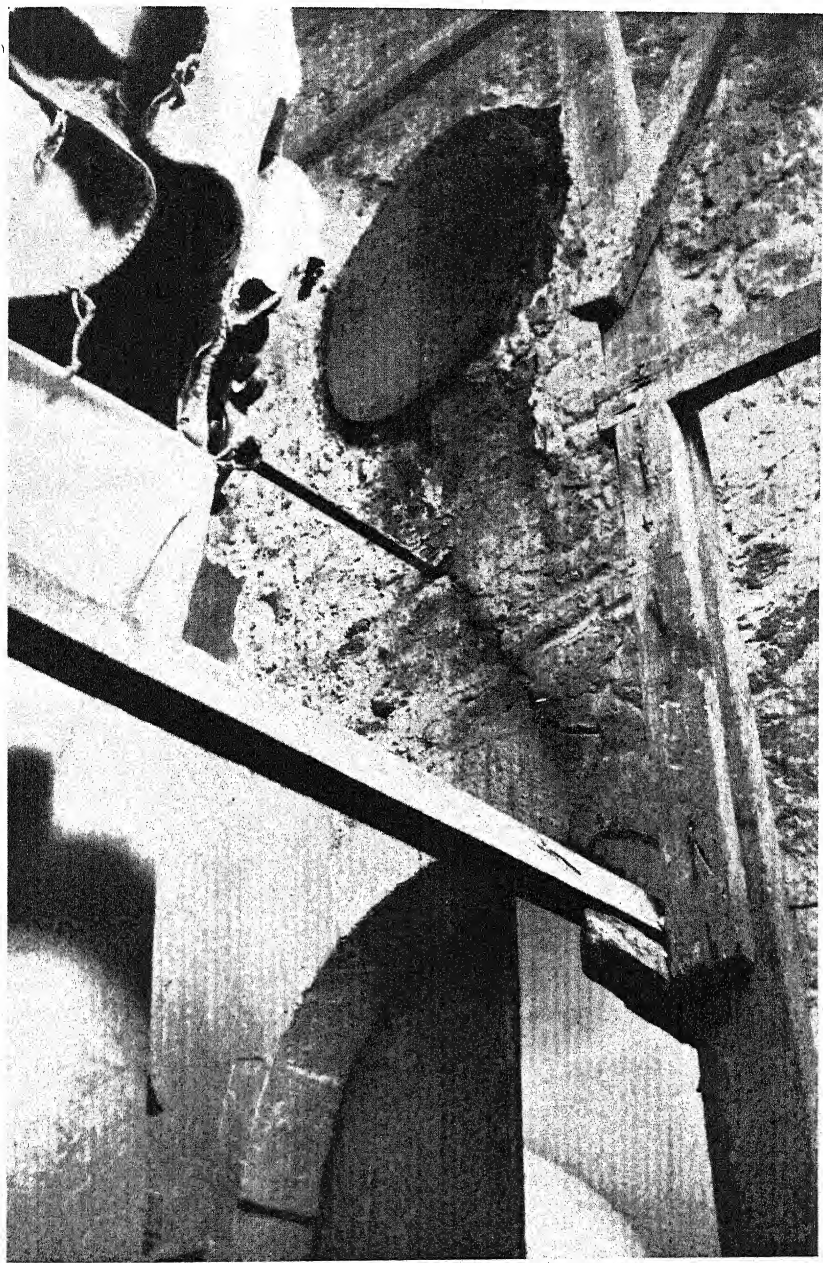
FIG. 38a. CRACK IN TRANSVERSE WALL OF ARMENIAN GALLERY
BEFORE RE-PLASTERING

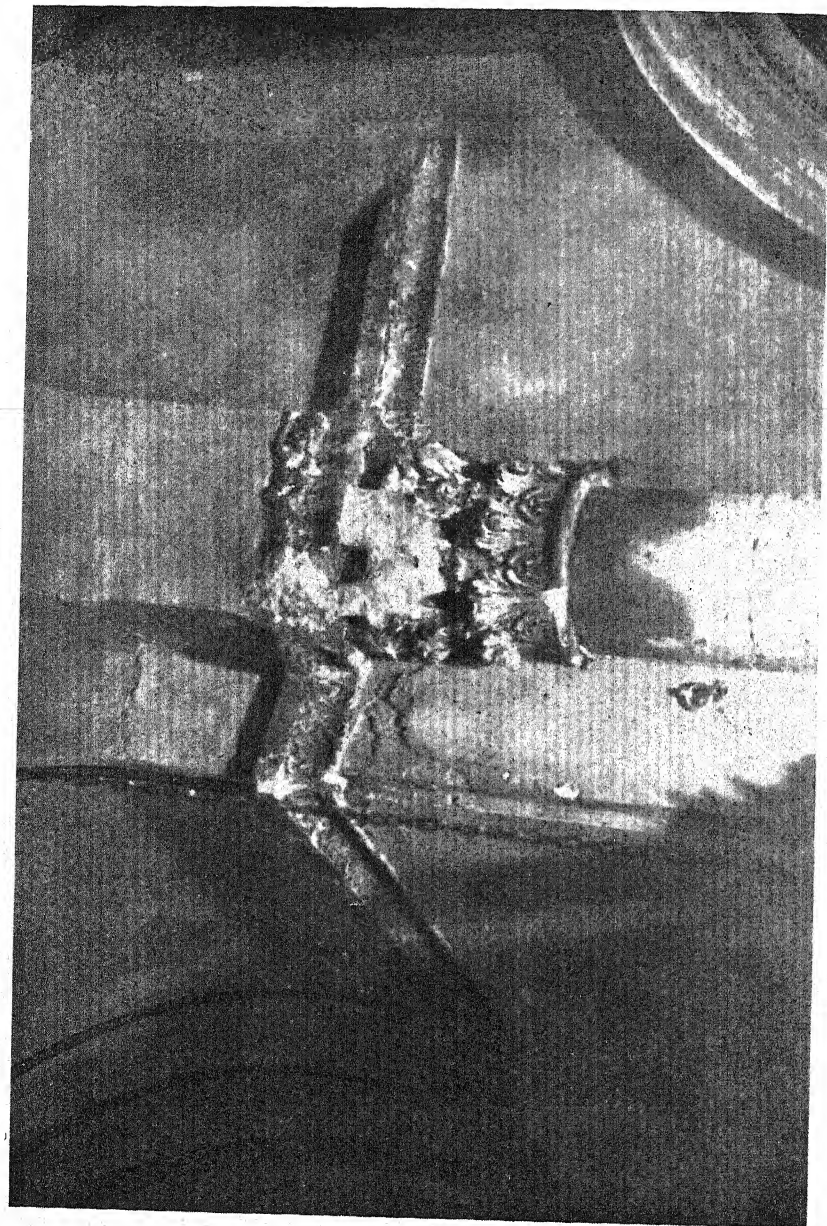
FIG. 43. CAPITAL DAMAGED RECENTLY. AMBULATORY

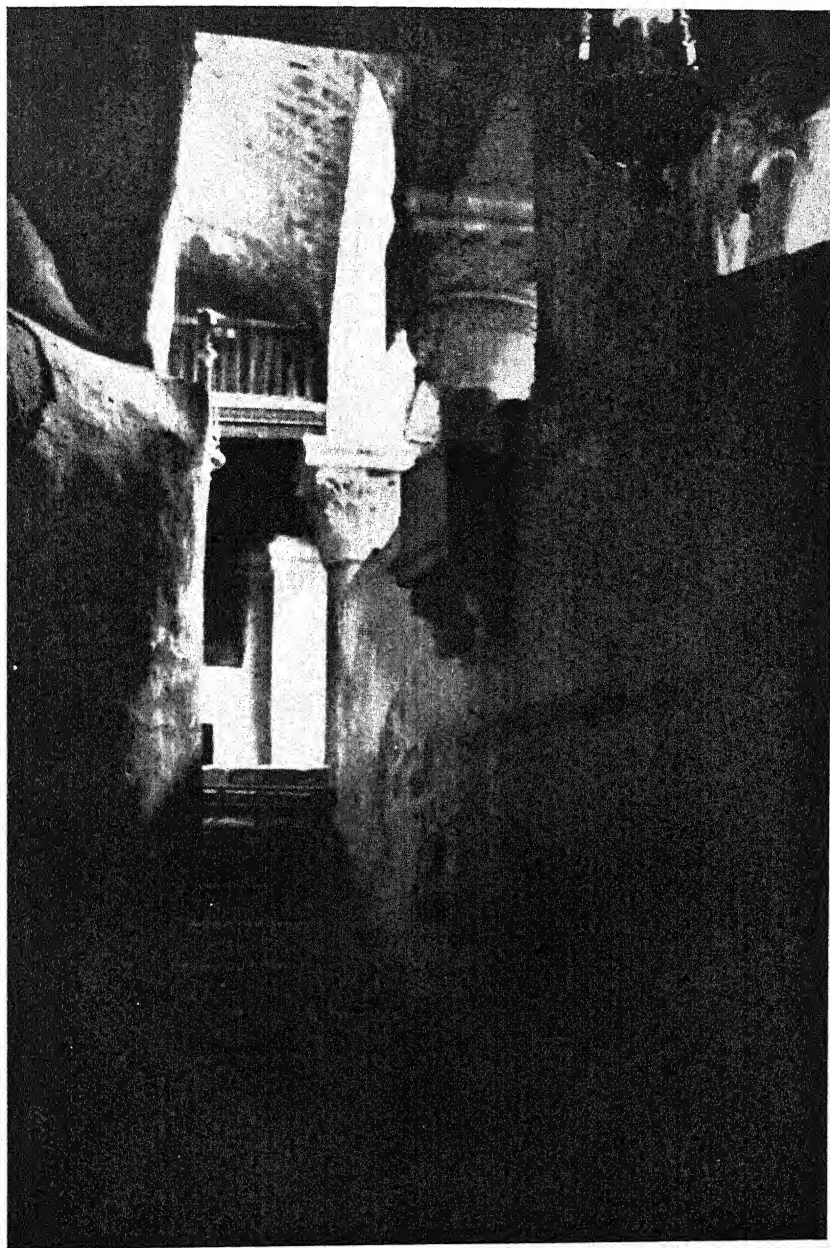
decay of structural consequence. The dome (see Fig. 46) leaks and requires water-proofing outside, as the rough-cast stucco has become badly cracked (see Fig. 47). The floor is in a bad state, also the flight of steps leading to the Grotto of the Invention (see Fig. 48); these are at present covered with iron gratings.

FIG. 48. STAIR TO GROTTA OF THE INVENTION

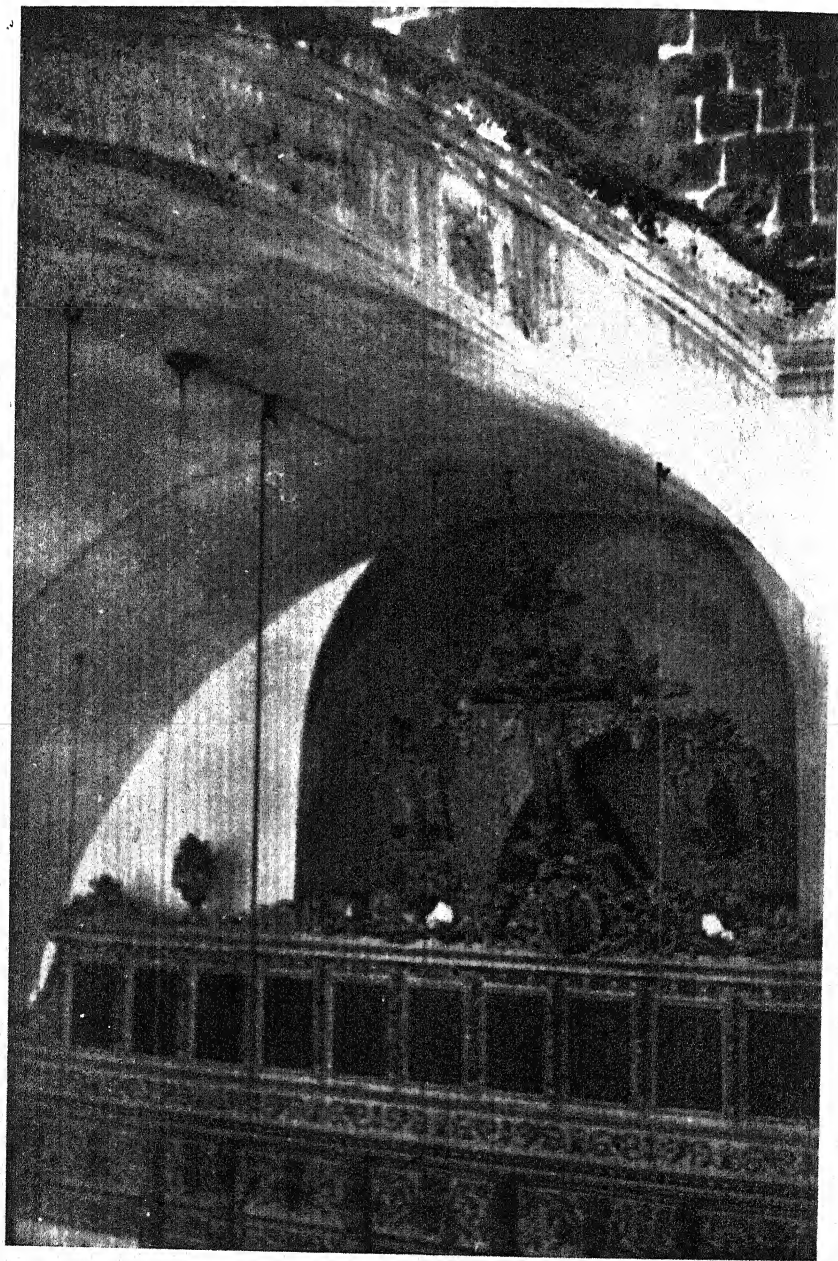
The Baptistry (see Figs. I, 32-II, 19), now partly open to the sky and in part vaulted over at a low level (see Fig. 59), shows little sign of decay in itself, but the thrust communicated to it by the Tower has succeeded in forcing its South wall outwards against the thrust of the vault of the Chapel of St. James (see Figs. 60, I, 33).

FIG. 59. VAULT OVER OLD BAPTISTERY

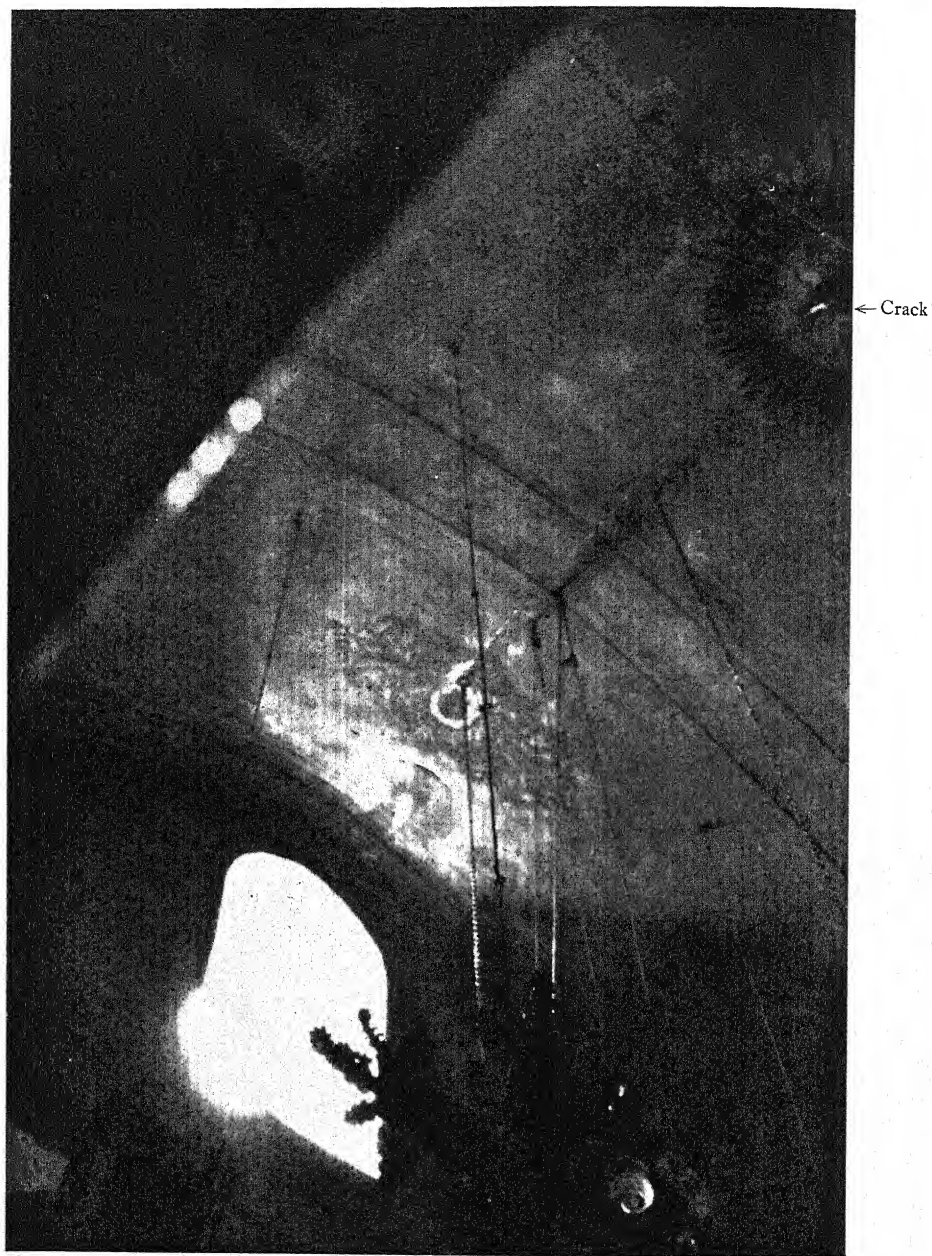
by $22\frac{1}{2}$ centimetres, and the crown of the vault is cracked throughout its length (see Figs. 63, V).

FIG. 63. VAULT OF CHAPEL OF ST. JAMES

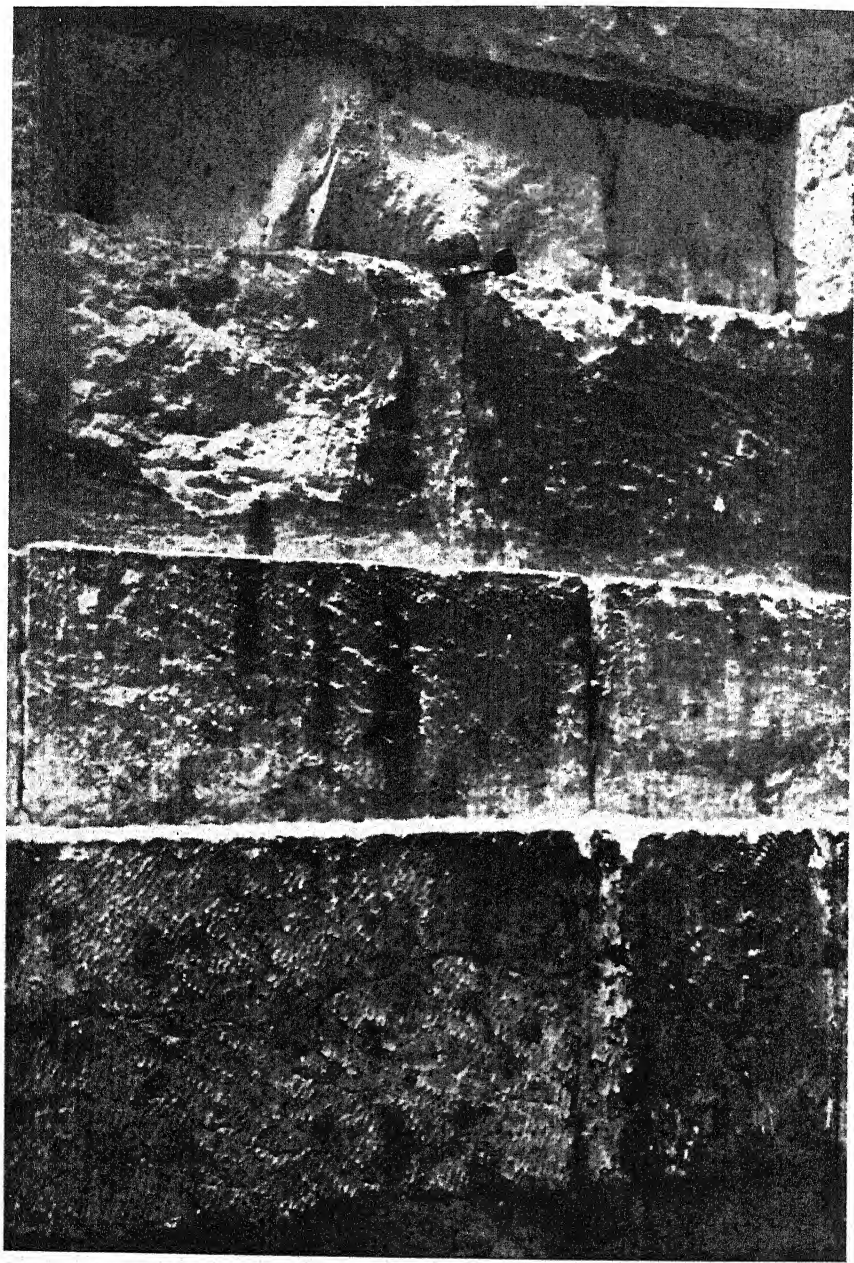
FIG. 65. FRACTURES DUE TO RUSTING IRON CRAMPS.
ROTUNDA PIERS

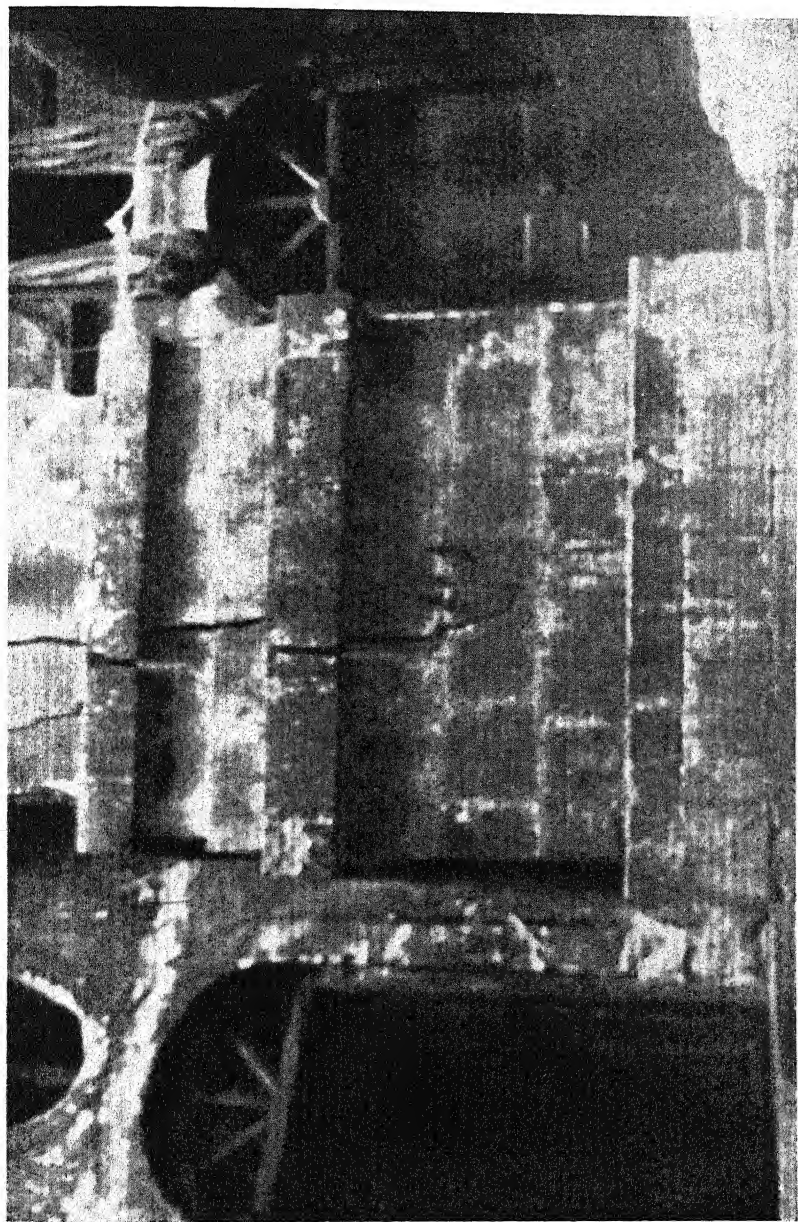
The piers of the main Rotunda (see Fig. I, 13) are now square (see Fig. 64), though they probably enclose as a core the earlier round columns of the building of Constantine Monomach (c. A.D. 1048). The present piers are clamped together with rusting iron (see Fig. 65), are very irregular in shape and size, and are not placed symmetrically beneath the circular drum built in 1867. They are therefore subject to eccentric loading, and all of them show cracks to a greater or less extent; some of these cracks are serious, though certainly due to earthquake shock as well as to thrusts (see Fig. 66).

FIG. 66. FRACTURED PIER AT W. OF ROTUNDA

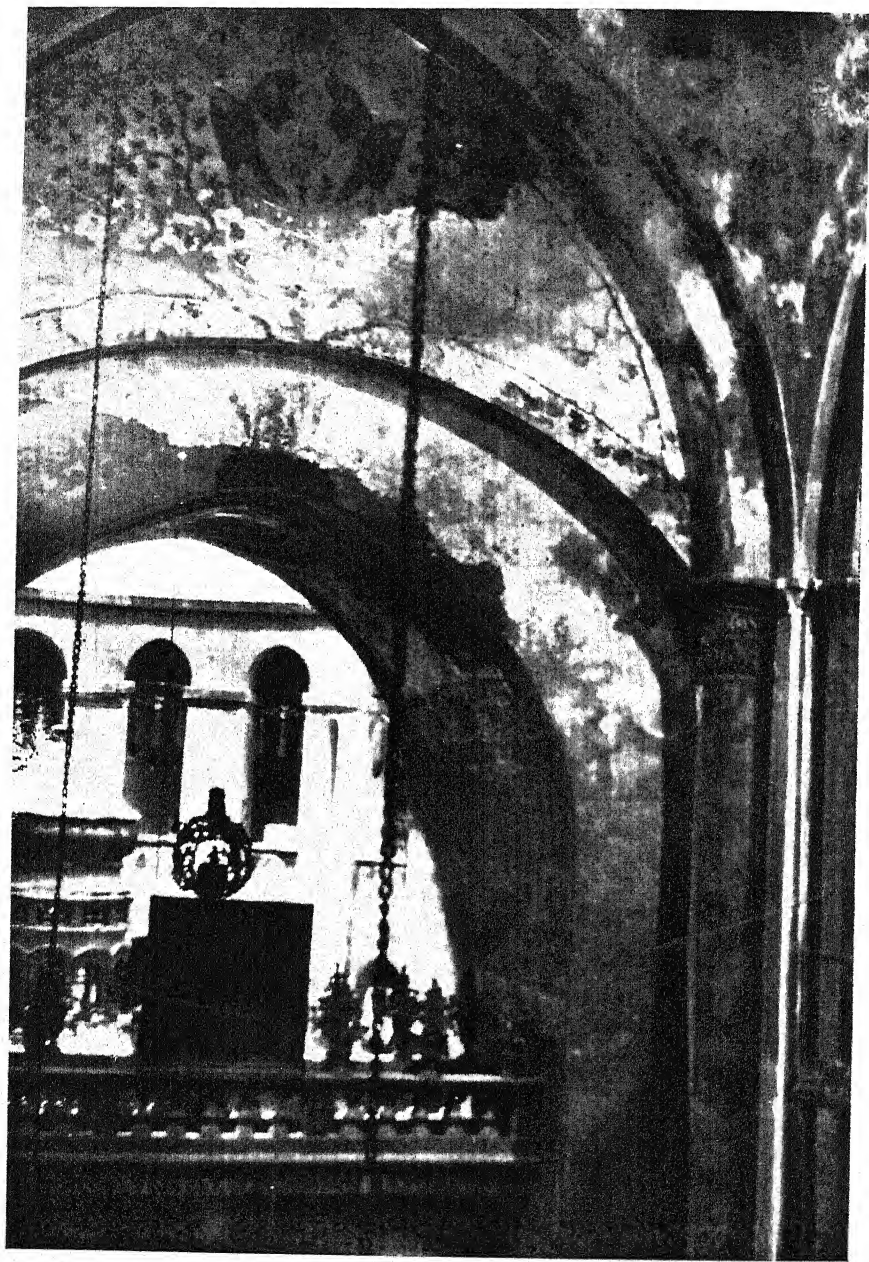
FIG. 74. GREAT ARCH OF ROTUNDA, SHOWING PLASTERING
OF 1810 CONCEALING CARVED WORK
